SUN LIFE HOME INSPECTIONS

INSPECTION REPORT BY SUN LIFE HOME INSPECTIONS COPY

1234 Main st.
CORAL SPRINGS, FL 33071

07/24/2022 9:00AM

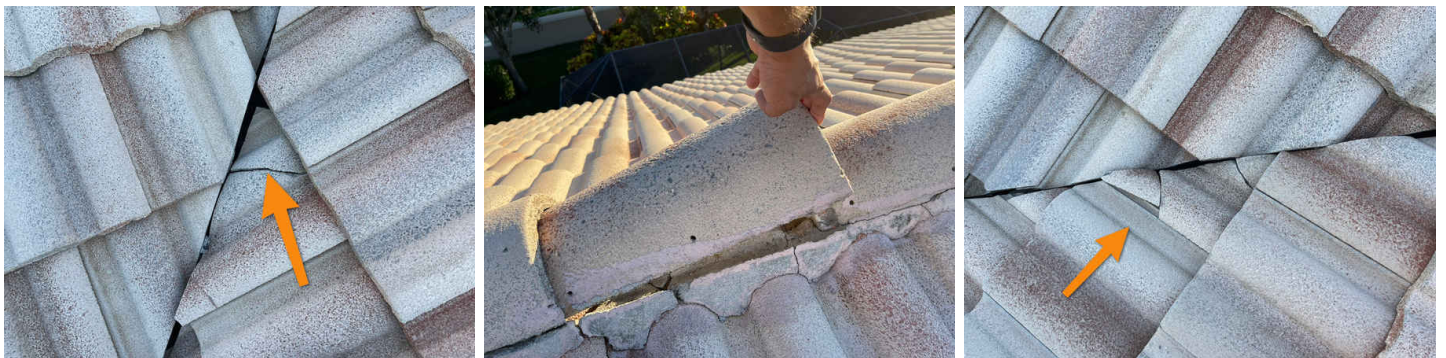
CRACKED AND DAMAGED ROOF COVERING

I observed areas of cracked/splitting and damaged roof-covering materials. This is a major defect. Prone to water leaking into the house. I recommend that a qualified roofing contractor to further evaluate and make repairs to the roof system,.

Contact a qualified roofing professional.

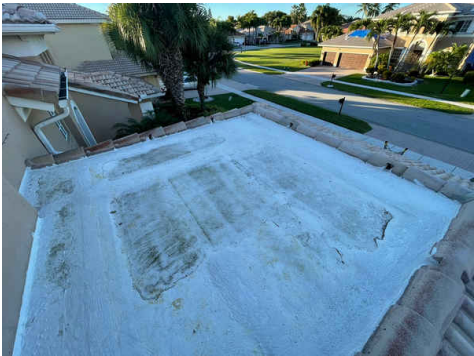
FLAT ROOF REPLACEMENT

The flat portion of the roof shows visible signs of age and due to the condition replacement is recommended. Have a licensed contractor to further evaluate and to correct as needed.

Recommendation
Contact a qualified professional.

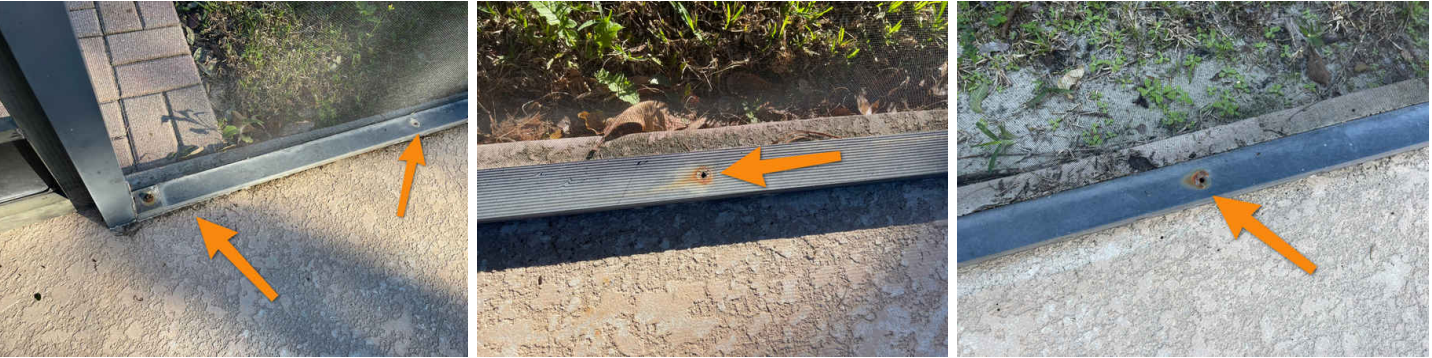
MISSING ANCHORS

Contact a qualified professional.

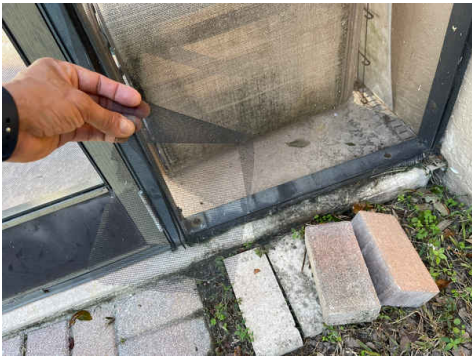
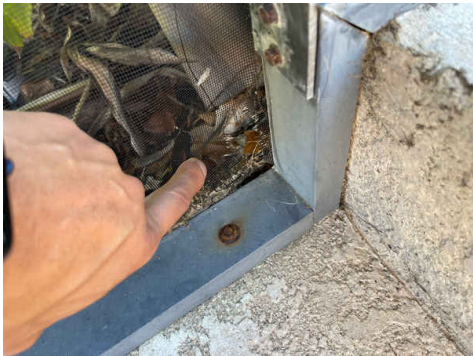
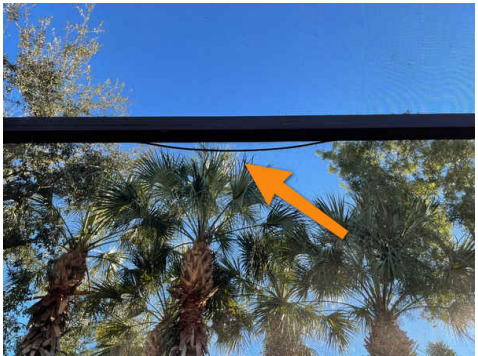
4.8.1 Porches, Patios, Decks, Balconies & Carports

The rear patio enclosure has torn or unattached screens at more then one location , recommend have a licensed contractor to further evaluate and to correct as needed

Recommendation
Contact a qualified professional.

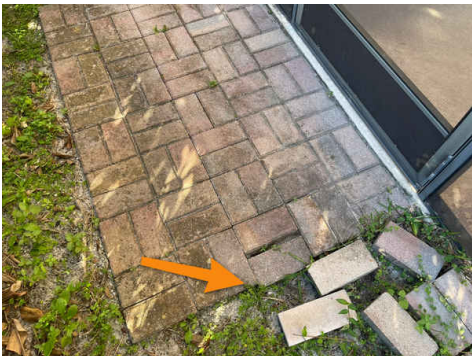
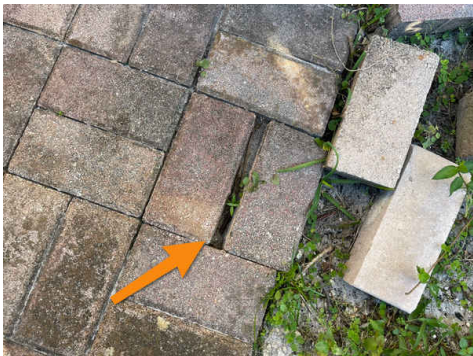
4.8.2 Porches, Patios, Decks, Balconies & Carports

The patio pavers shows visible signs of shifting at the right side of the home. Recommend having a licensed contractor to repair as needed

Recommendation
Contact a qualified professional.

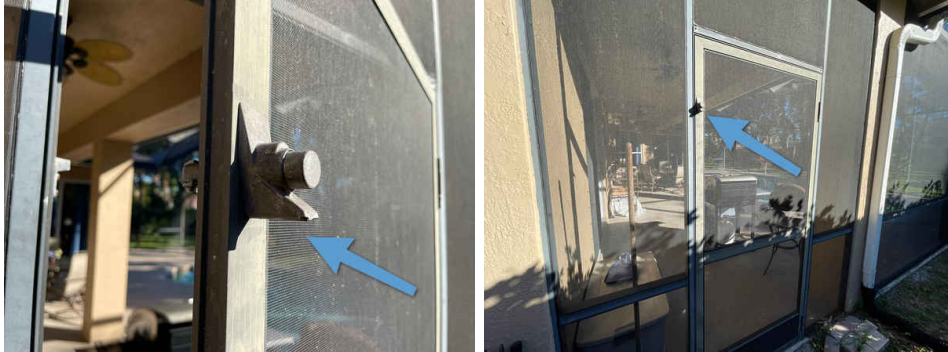
4.11.1 Exterior Doors

SCREEN DOOR DEFECT

The lock assembly does not latch close, also shows visible signs of damage. Recommend having a licensed contractor to further evaluate and to correct as needed.

Contact a handyman or DIY project

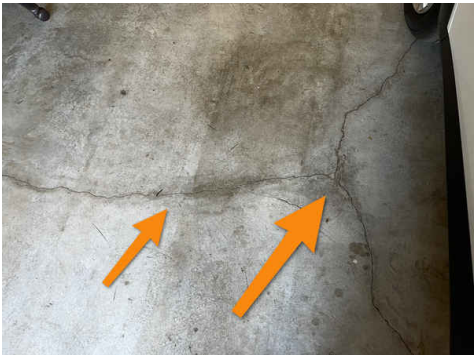
TYPICAL CRACKS

The garage floor shows visible signs of typical settlement cracks. Recommend to repair as needed

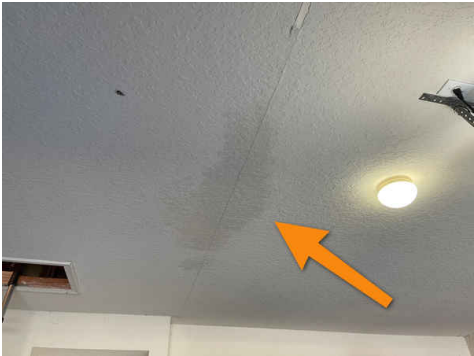
5.6.1 Ceiling, Walls & Firewalls in Garage

CEILING OLD WATER STAINS

The garage ceiling shows visible signs of previous moisture intrusion (tested dry when tested with a moisture meter) Recommend to repair as needed.

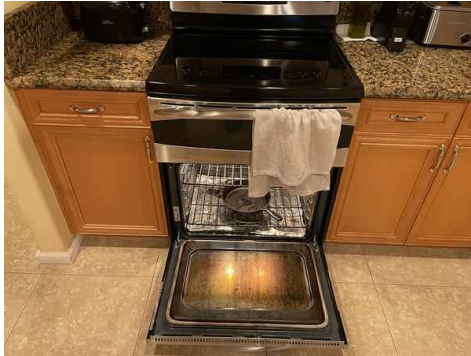
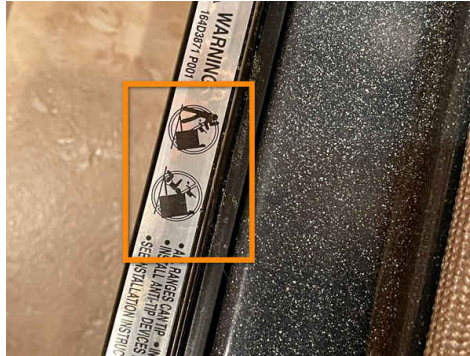
Major Defect**MISSING ANTI-TIP**

I observed that the stove and oven appliance was not fastened to the wall or floor. Anti-tip device is missing. This poses a safety hazard to children.

Contact a qualified professional.

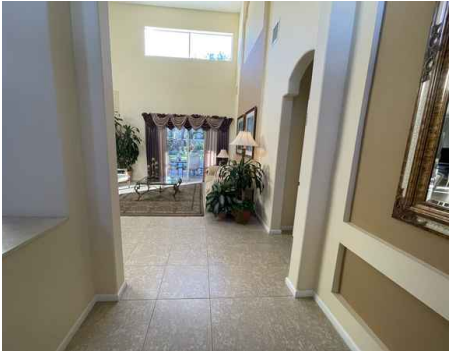
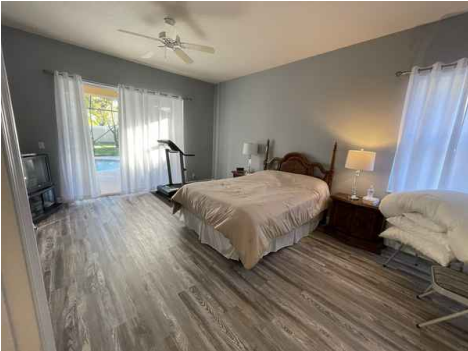
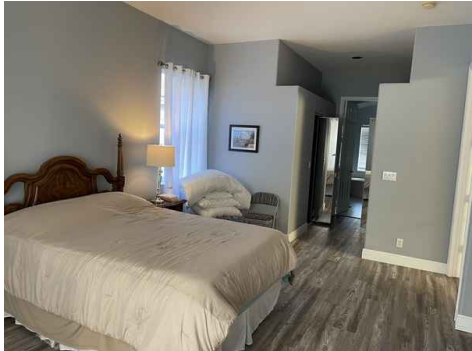
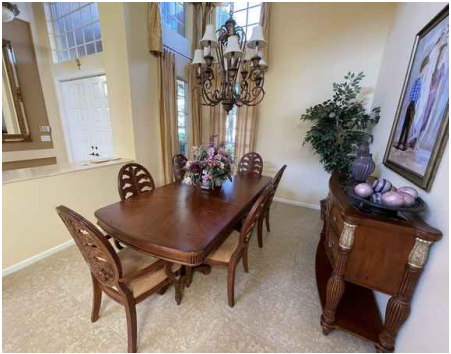
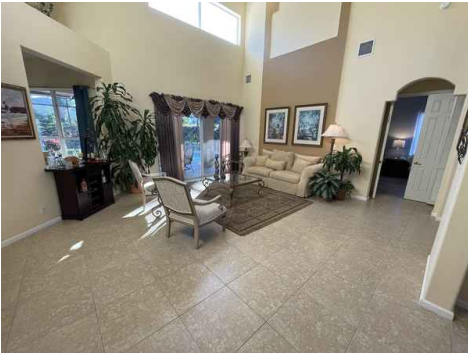
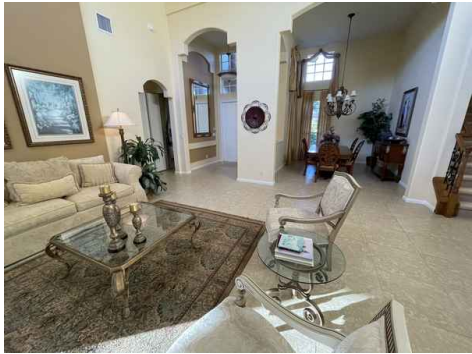
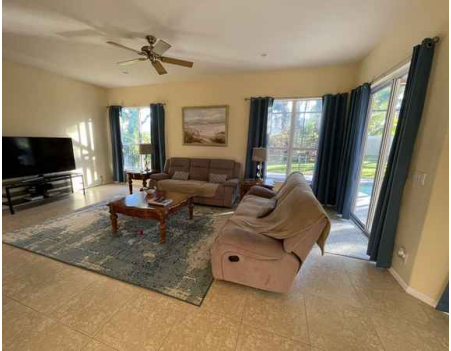
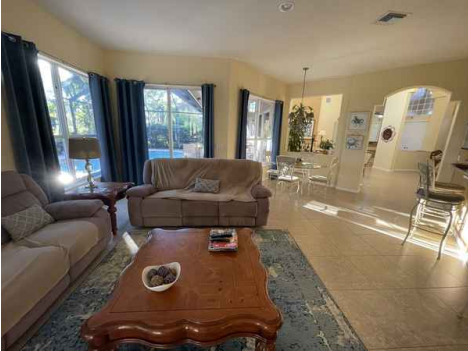
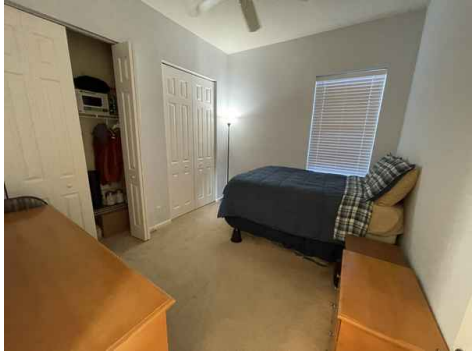
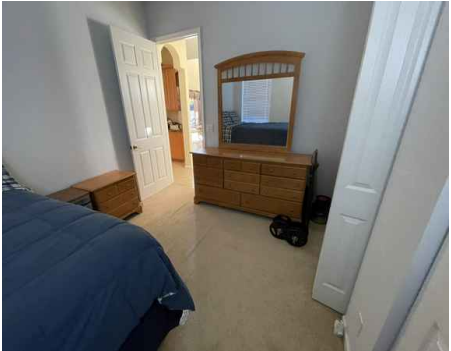
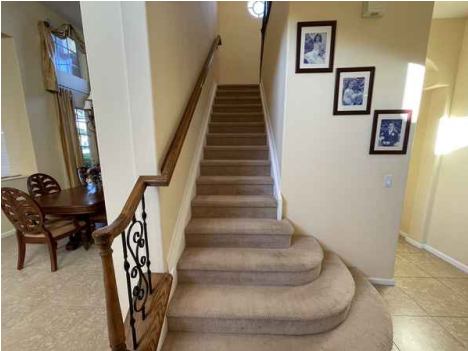
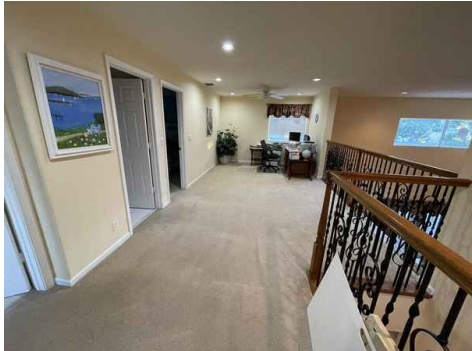
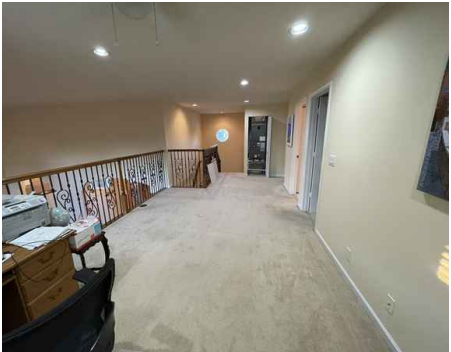
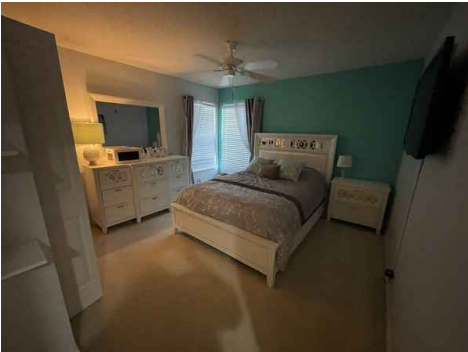
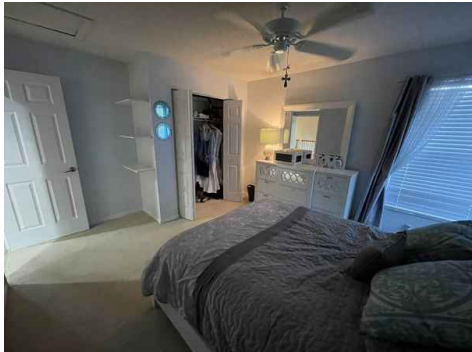
General Info: General Pictures

General Info: Ceiling Materials Drywall	General Info: Wall Covering(s) Drywall	General Info: Floor Covering(s) Carpet, Laminate, Tile
General Info: Interior Doors Bi-Fold, Frenchwood, Sliding Glass, Panel	General Info: Window Types Fixed, Single Pane, Single Hung, Sliders

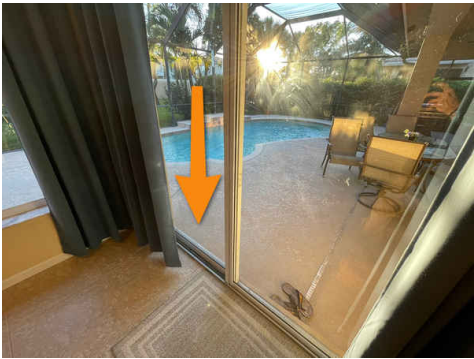
The sliding glass door does not glide freely on its tracks. Recommend having a licensed contractor to further evaluate and to correct as needed

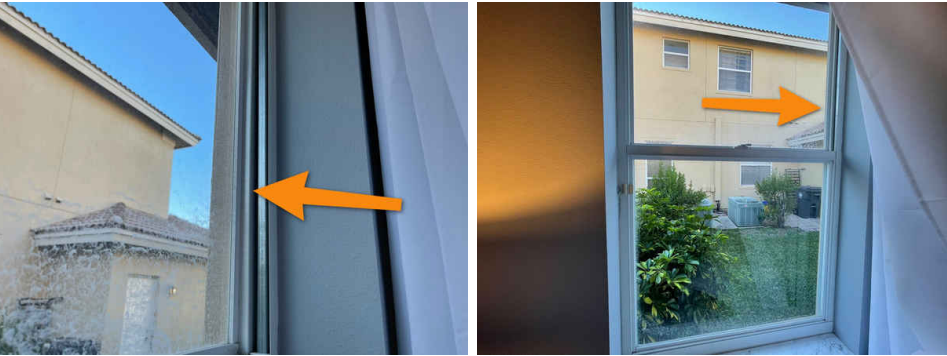
7.3.1 Windows

BROKEN BALANCE ROD

The window has a broken balance rod at the master bedroom Recommend having a licensed contractor to further evaluate and correct as needed.

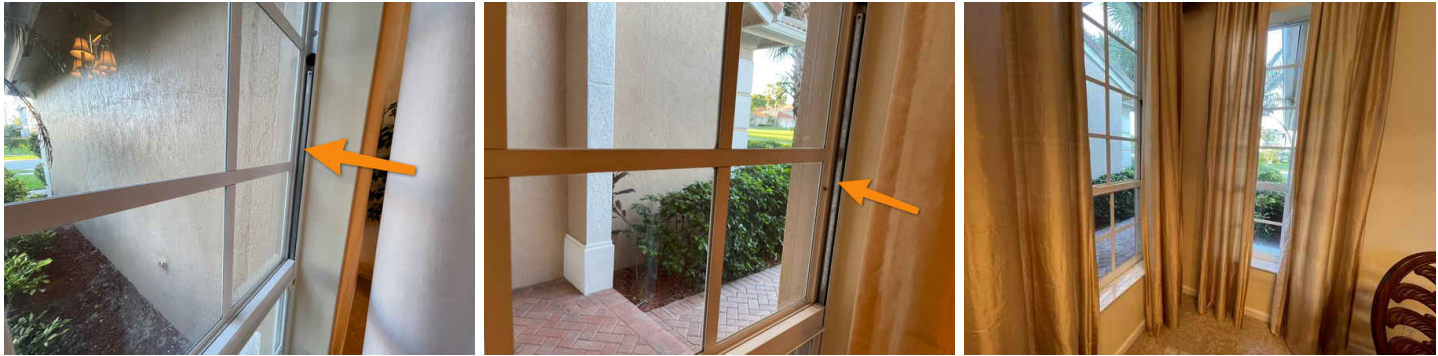
7.3.2 Windows

BROKEN BALANCE ROD

The two windows have broken balance rods at the Dining room. Recommend having a licensed contractor to further evaluate and correct as needed.

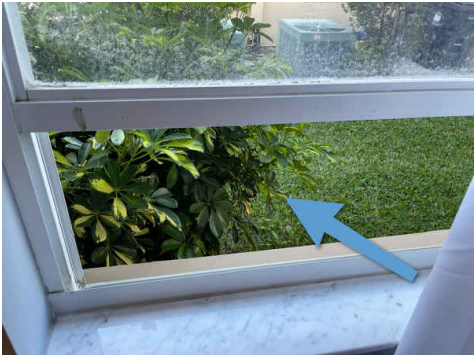
7.3.4 Windows

MISSING SCREENS

The window screens are missing or not installed add one more locations throughout the home. Recommend to correct as needed

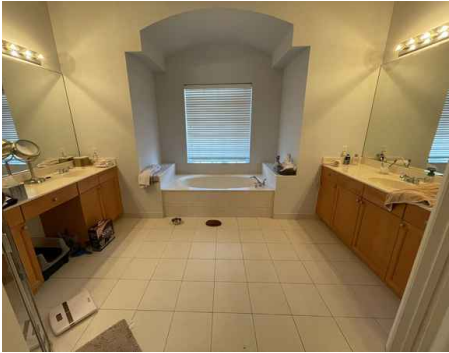
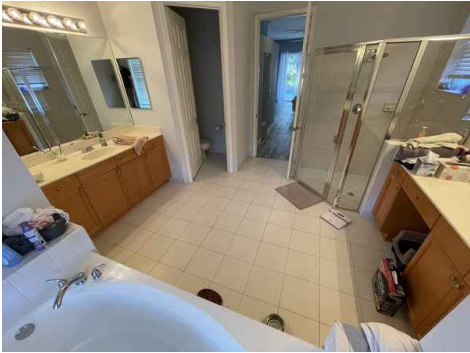
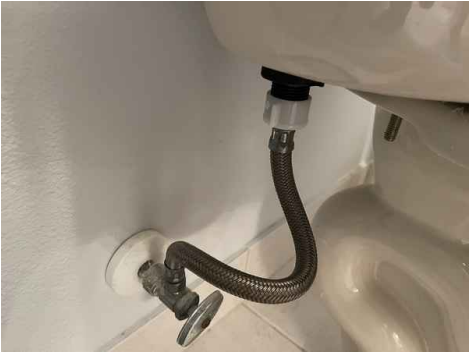
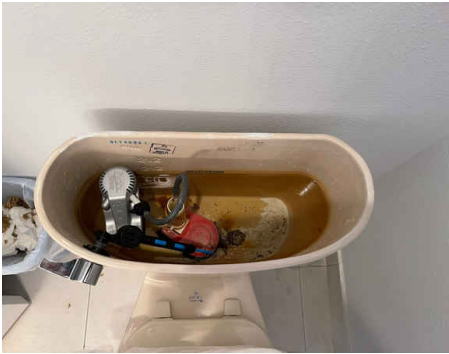
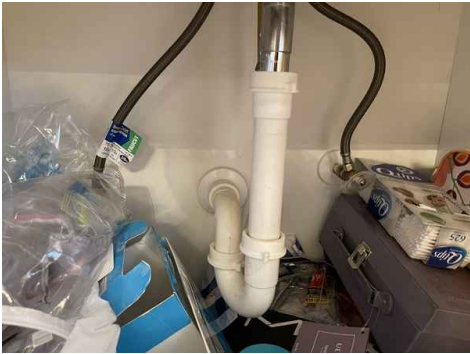
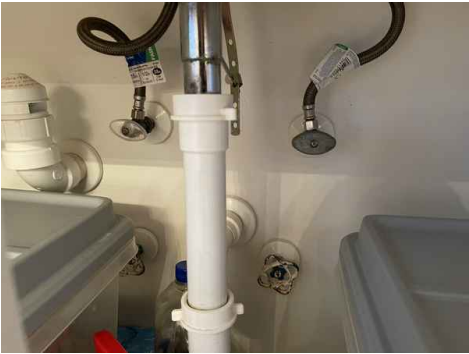
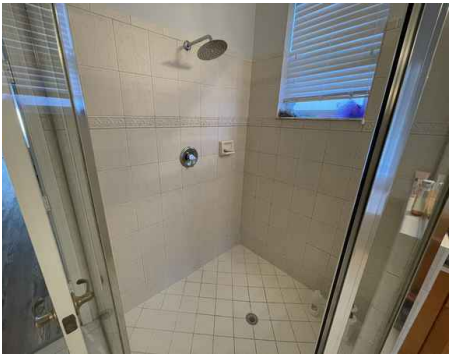
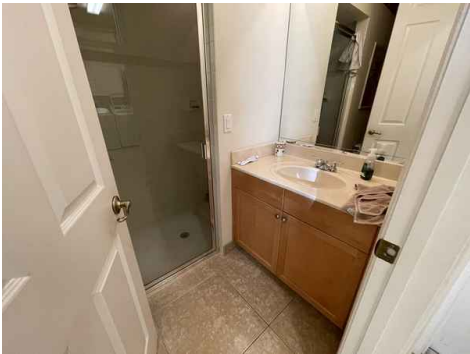
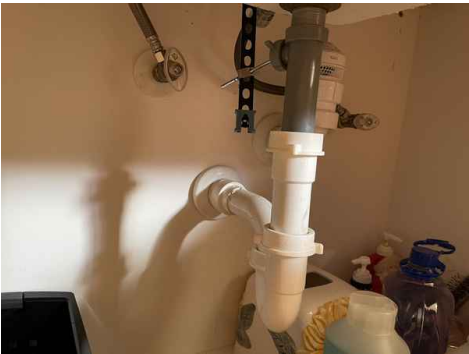
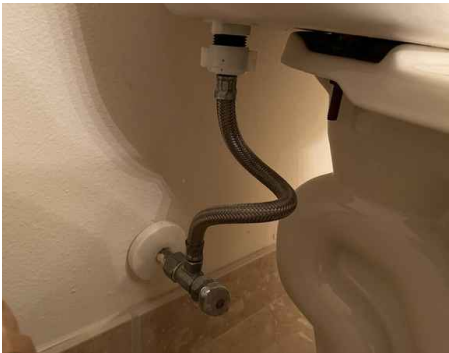
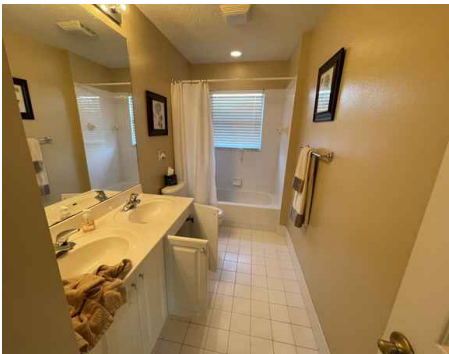
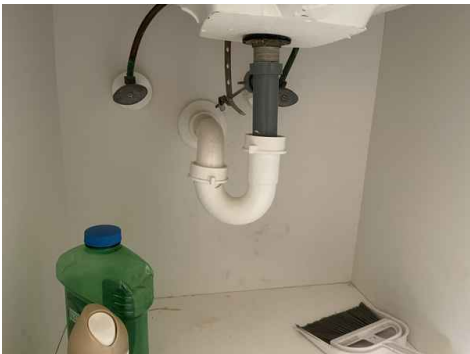
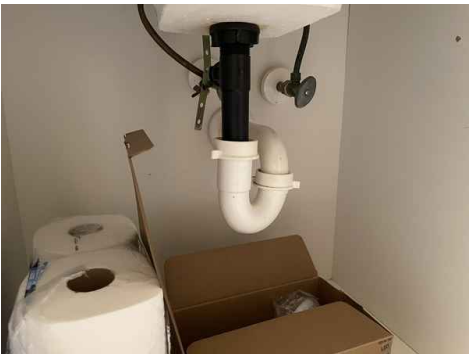
General Info: General Pictures

General Info: Components Tub, Shower Stall, Toilet	General Info: Sink/Faucet Type Single, Double, Single Lever, Double Handle	General Info: Countertop Type Cultured Marble
General Info: Cabinetry Wood	General Info: Wall Coverings Paint, Tile	General Info: Exhaust Fan Fan
Bathroom Toilets: Toilets Inspected I flushed all of the toilets.	Heat Source in Bathroom: Heat Source in Bathroom Was Inspected I inspected the heat source in the bathroom (register/baseboard).

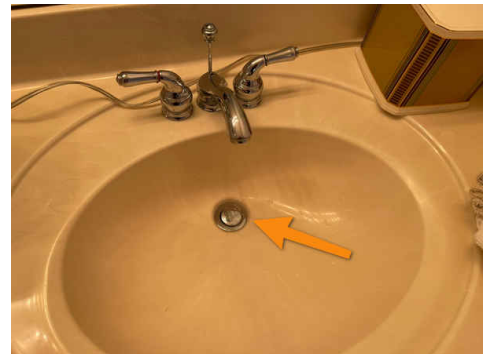
The sink stopper mechanism does not hold water when used at the left side sink in the master bathroom. Recommend having a licensed contractor to further evaluate and to correct as needed

Contact a qualified professional.

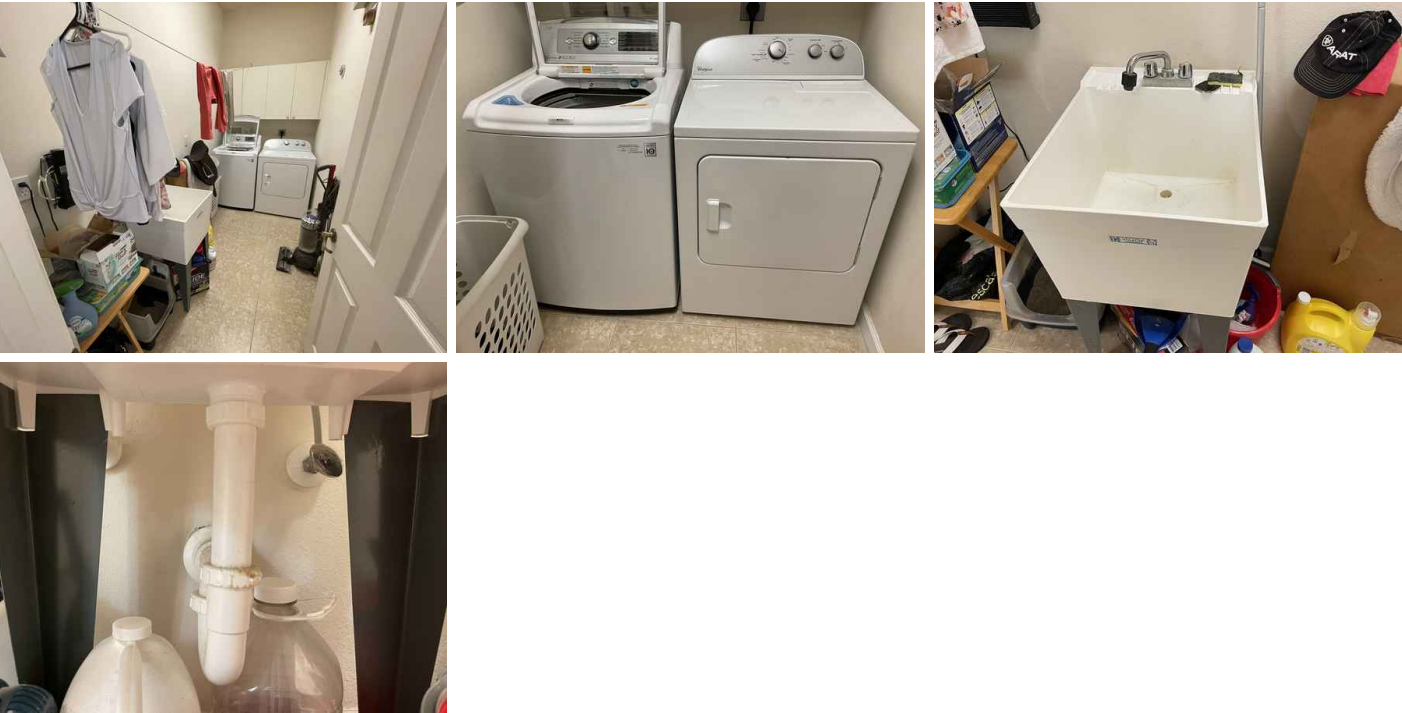
General Info: General Pictures

General Info: Washer LG	General Info: Clothes Dryer Whirlpool	General Info: Clothes Dryer Vent Material Flexible Metal
-----------------------------------	---	--

Dryer exhaust hoses are not checked for blockages, inspection company recommends monthly cleaning as needed.

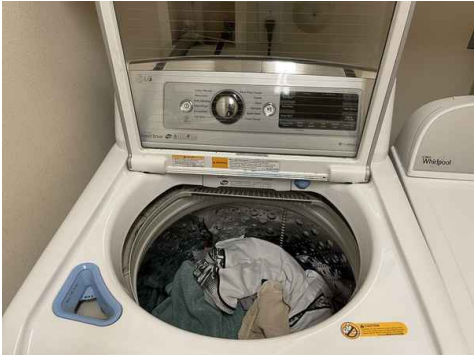
I did not inspect the clothes washer fully. These appliances are beyond the scope of a home inspection. I did not operate the washer machine (unit was full with owner's clothes)

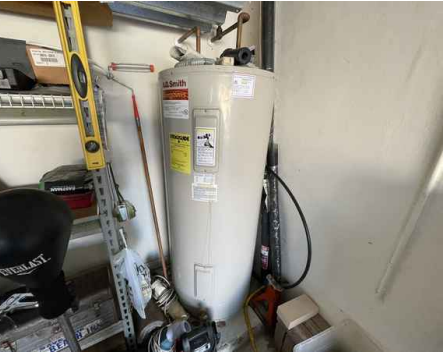
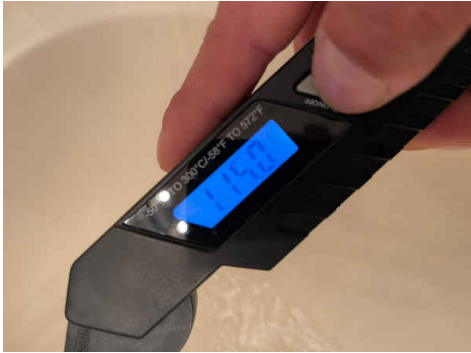
General Info: General Pictures

I inspected the temperature and pressure relief valve.

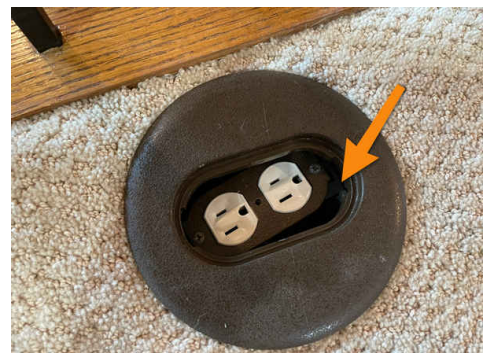
11.10.2 Electrical Defects

OUTLET LOOSE

Contact a qualified professional.

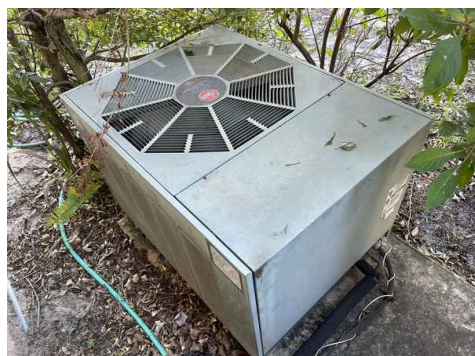
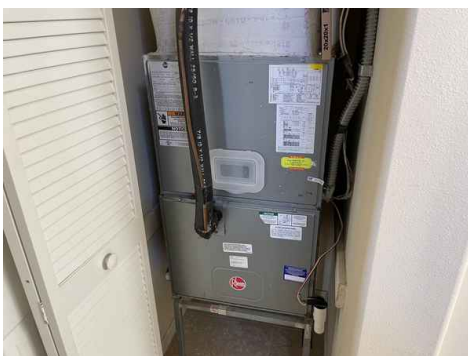
12.4.1 Condensate

CONDENSATE DISCHARGE SHOULD BE EXTENDED

The condensate discharge pipe should be extended so that the water is diverted far enough away from the house foundation.

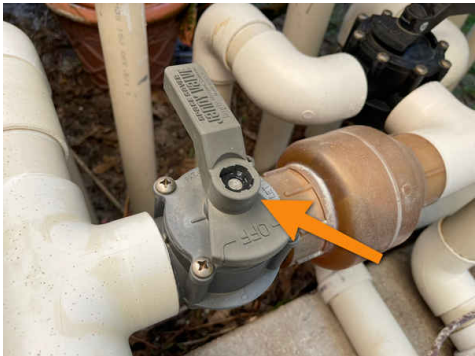
LOCK NUT MISSING

The lock nut on the jandy valve is missing, recommend have a licensed contractor to further evaluate and to correct as needed

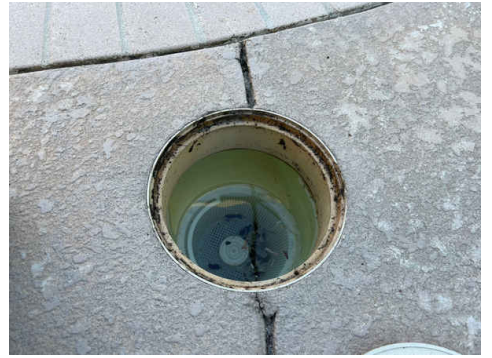
13.8.1 Overflow skimmers and drains

SKIMMER WEIR MISSING

Contact a qualified professional.
